Manhole Inspection Summary

Manhole # S31CC_029MH

Insp Date: **2/6/07 9:48 AM**

Location Address: **PRESTON ST**

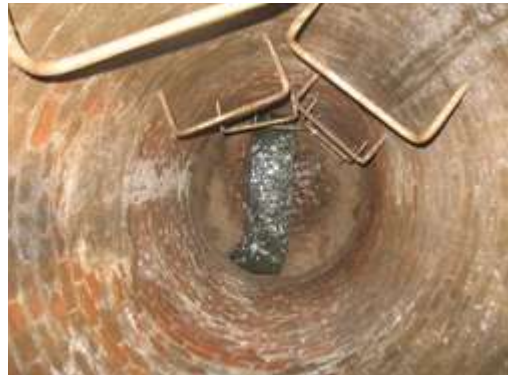
Top View

Bench debris.

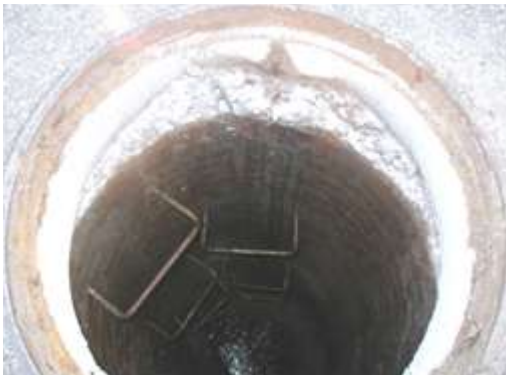
Defect

Frame leaks. Frame offset. Adjustment infiltration - other side.

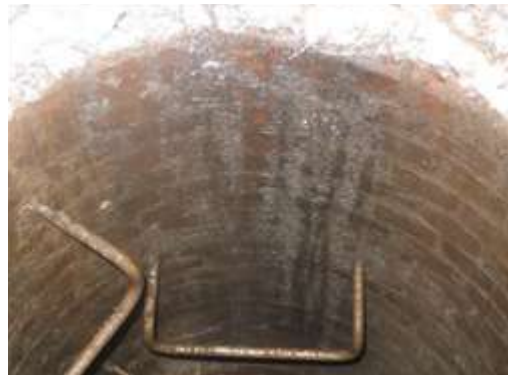
Defect

Frame leaks. Frame offset. Adjustment infiltration.

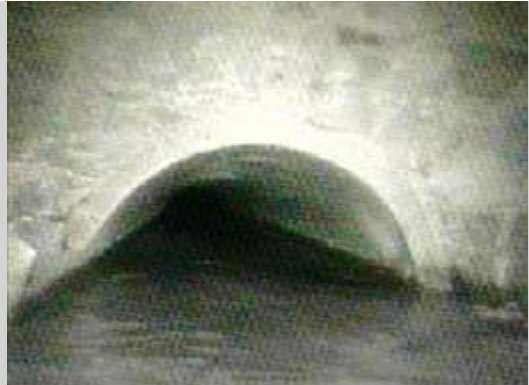
12 in. Circular Gravity Sewer Pipe Out @ 12 O'Clock

Infiltration: **Evidence** Pipe Seal Cond: **Unknown**

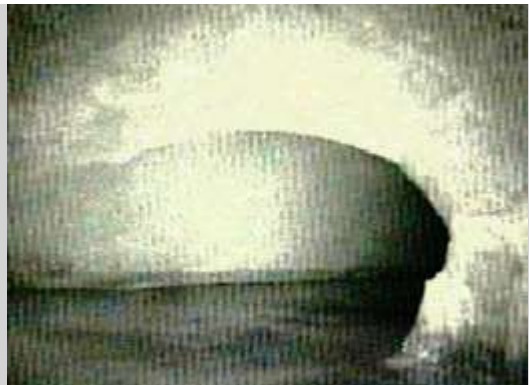
10 in. Circular Gravity Sewer Pipe In @ 7 O'Clock

Infiltration: **Evidence** Pipe Seal Cond: **Unknown**
